Nondestructive Testing for AmericaOne

Ron Predmesky and Matt Zaluzec

Ford Motor Company, Dearborn, MI

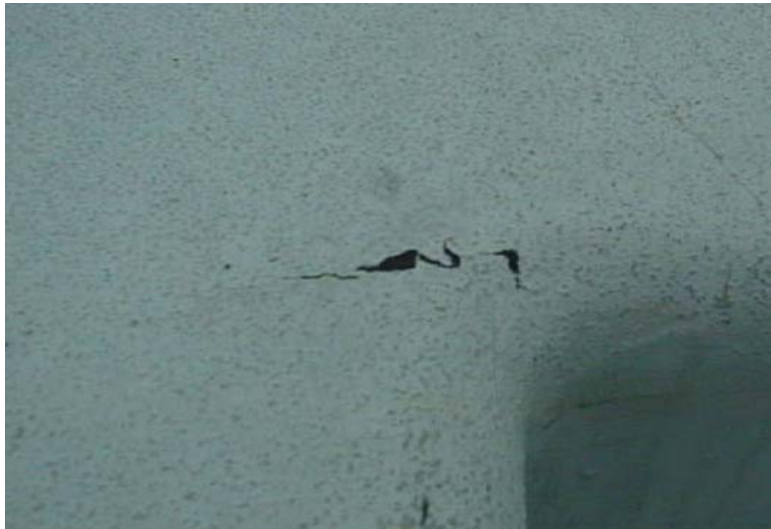
Fig. 1 is a photograph of the port side cockpit on US49. This was originally thought to be a separation between the deck skin and the composite. It was found through infrared inspection that there was a delamination in the composite below the deck skin. Fig. 2 is the corresponding thermogram

Figure 1. Photograph of a defect on the port side cockpit on US49

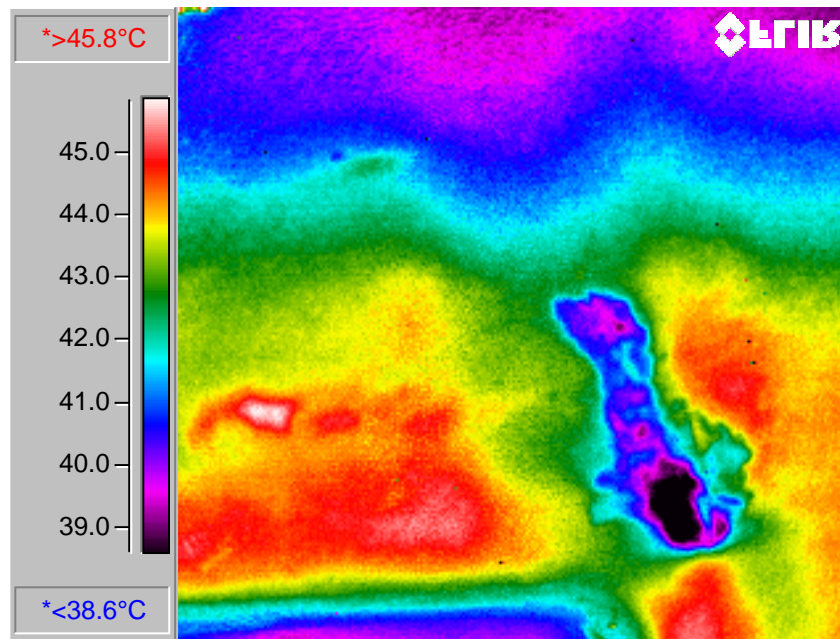
Figure 2. Thermogram of the defect illustrated in figure 1

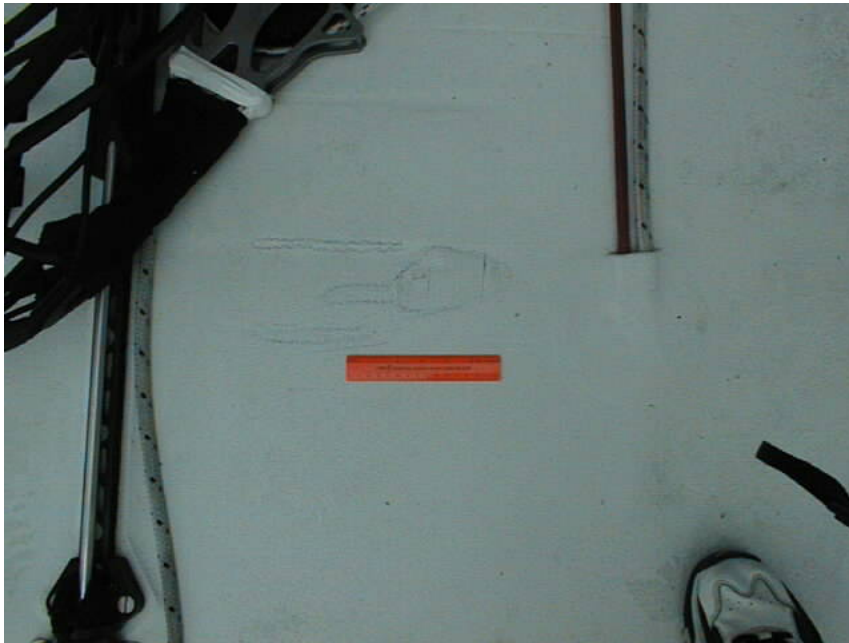
Fig. 3 is a photograph of a defect on the fore deck of US61. This was a delamination that was found in a critical area. Fig. 4 is a thermogram of the defect.

Figure 3. Photograph of a defect on the foredeck of US61

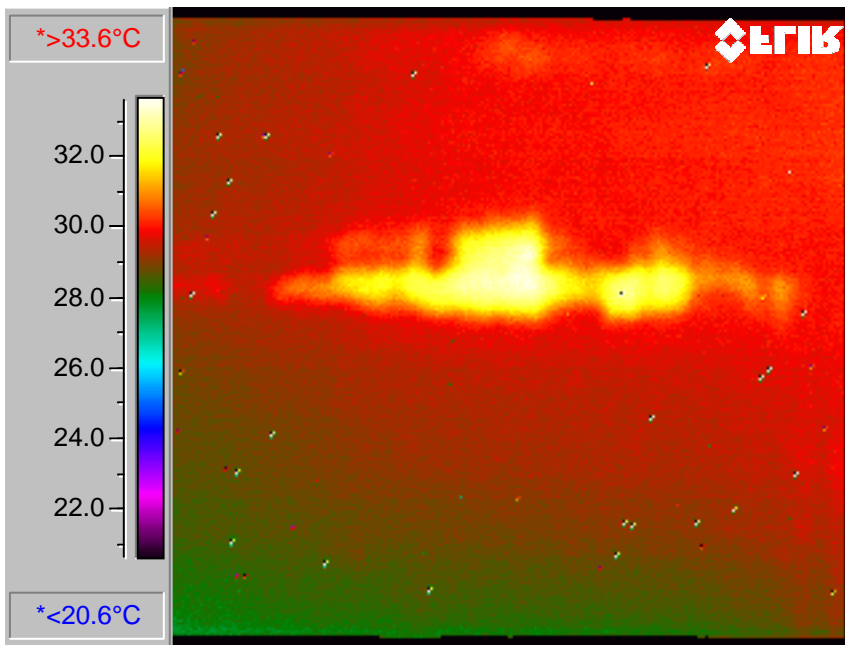
Figure 4. Thermogram of the defect shown in figure 3
