# Thermographic evaluation of concrete masonry walls: have they been properly reinforced?

Gregory R. Stockton

Stockton Infrared Thermographic Services, Inc., Randleman, NC

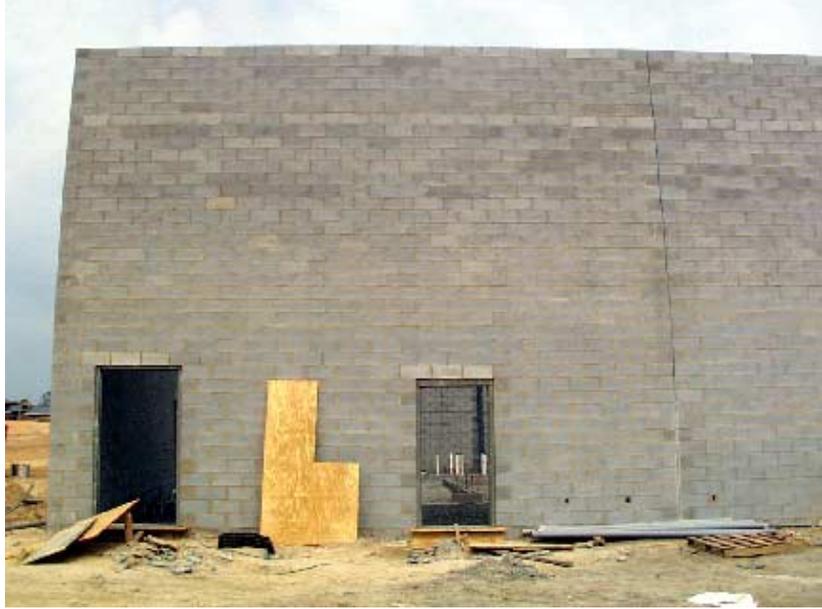
**Figure 1. Typical CMU wall section.**

So until the occupants are miserable, damage is occurring or the operation is affected, and as long as energy prices remain relatively low, heat loss is not perceived to be a problem by building owners. That is why performing heat loss surveys for a living does make the basis of a very good infrared business. Below, I will deal with the structural inspection of the walls of one type of building: CMU or concrete masonry unit. Fig. 1 is a photograph illustrating typical CMU construction.

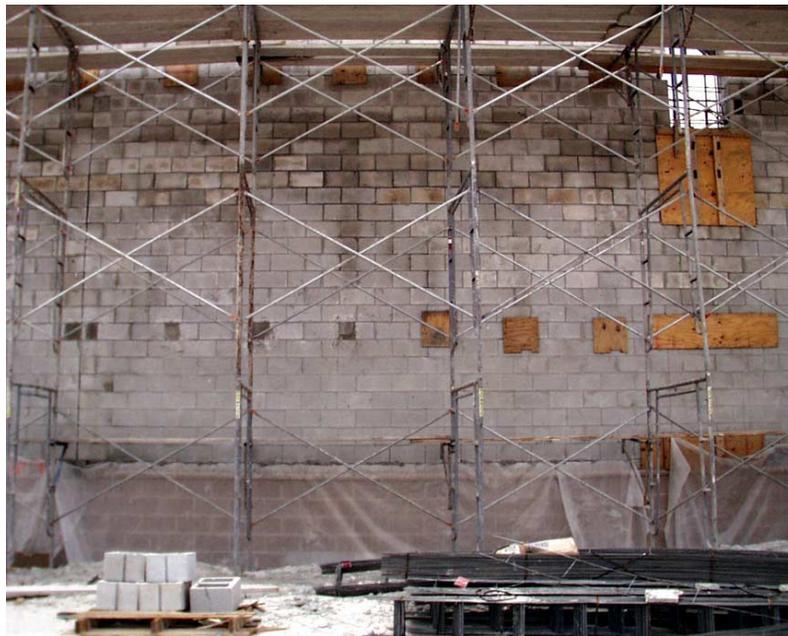
**Figure 3) CMU wall section with inspection ports.**

We find many problems with the construction of CMU walls, but judge these defects are almost never caused by fraud. Instead, poor supervision on the job is the cause for the poor quality. Some buildings are effectively grouted, but it takes extreme and costly measures. For years, the only way that a building owner had of looking into a masonry wall was to drill (or hammer) a hole in it. This testing method does not work, because only a small sample is tested. X-ray testing is *so* slow and expensive, that it is usually cheaper to knock the wall down and start over if its structural integrity is called into question. If the owner really wants to make sure that the grouting and rebar are in the wall, the most popular means is to require the installation of inspections ports or holes, cut in the block faces. These are installed at every lift height and at all grouted vertical pilaster locations as shown in Fig. 3. This is a very costly, time-consuming and sloppy method. That is why infrared is so valuable. It is fast, inexpensive and accurate.
