Should panel covers be removed to perform an IR survey of electrical switchgear?

By Gregory R. Stockton

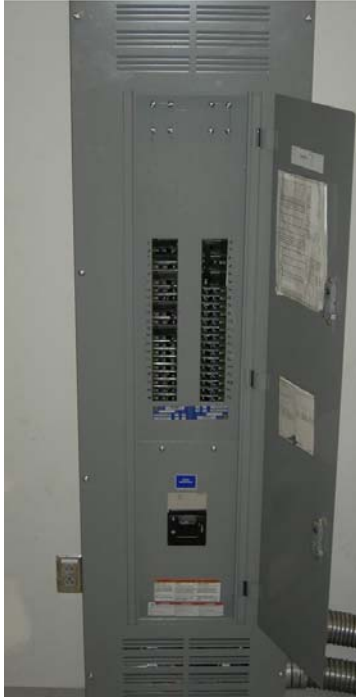
Figure 1 – Typical electrical panel

- 1) It is almost impossible to tell the difference between a medium-loaded breaker in a panel and a breaker with a loose bus connection (see Figures 1-5). So in order to perform a dutiful survey, the thermographer would need to report for removal, almost every panel that contains even a slightly loaded breaker. What is the sense in going through, for example, 500 panels, finding some heat on 400 of them and having them taken apart and re-inspected on a separate mobilization? –Or waiting around for the electricians to remove the panel.

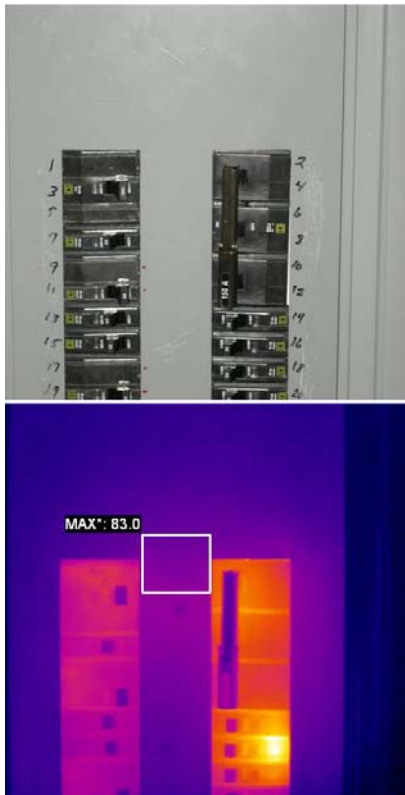
.Figure 2 – Visual and thermal image of a panel with covers on.

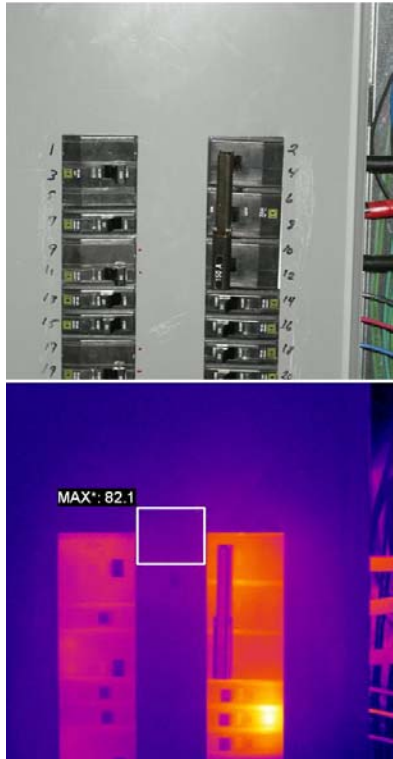
Figure 3 – Visual and thermal image of a panel with only the deadfront cover on.

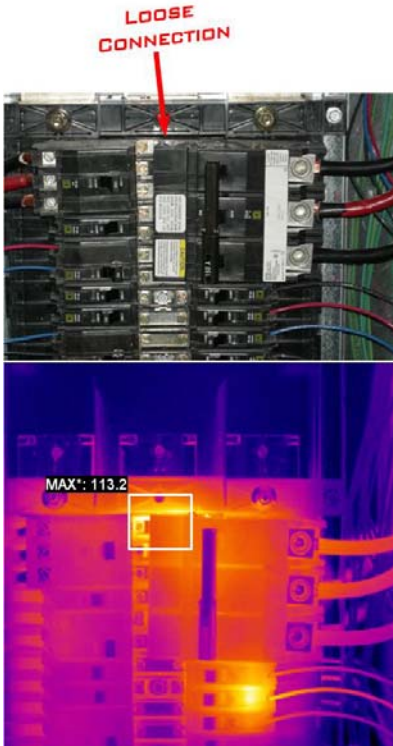
Figure 4 – Visual and thermal image of a panel with both covers removed.

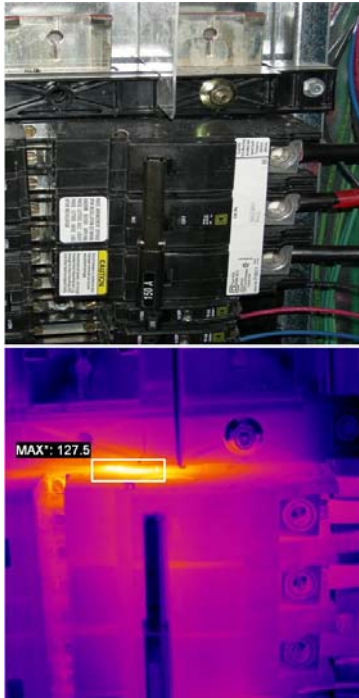
Figure 5 – Visual and thermal image of a panel with both covers removed at the proper angle to see the problem.

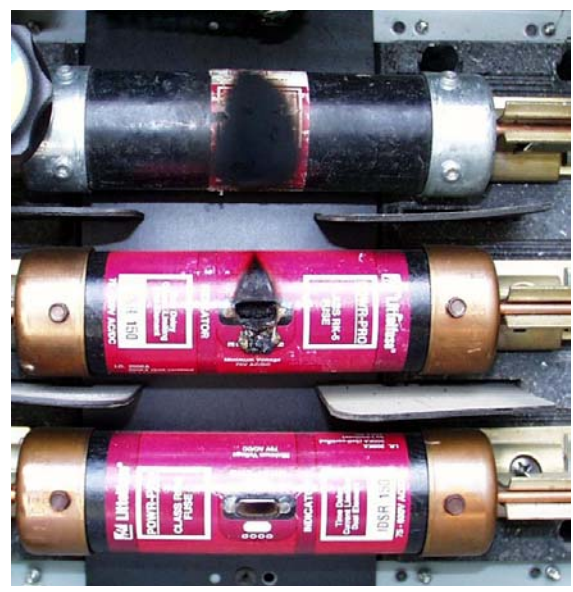
Figure 6 – Fused disconnect showing blown fuse.

- 4) Visual inspection of the inside of a panel by a trained eye is a bonus by-product of any IR inspection and should not be discounted. Visual inspections sometimes reveal problems that cannot even be seen with IR...like broken components and burn marks left from a cyclical thermal event, a circuit that is not operating or a failed component (see Figure 6).
